Re: 54-106 KA-6535-02
NHPP-A653(502)
Butler and Sedgwick County

Archeological Survey of KDOT Project #54-106 KA-6535-02 (KA-6535-RCNS-01), in Sedgwick and Butler Counties, Kansas

By: Chris Herriage
 Contract Archeology Program, Cultural Resources Division
 Kansas Historical Society
 September 22, 2022

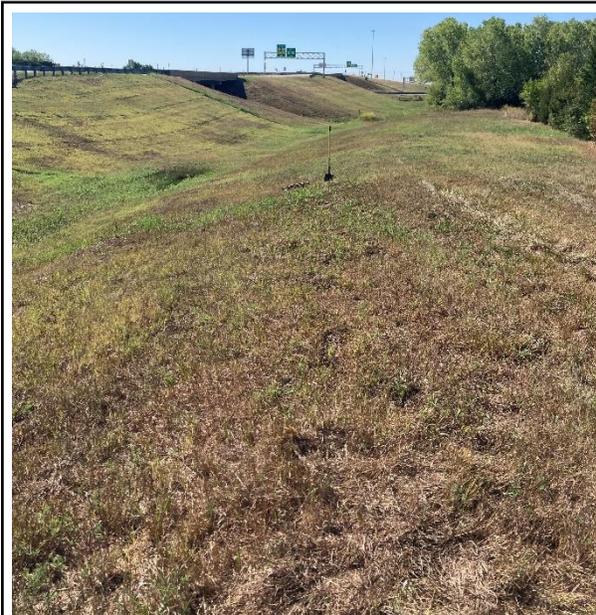
Figure 4.1. Image showing disturbances on the west side of K-96, facing south.

Survey began on the west side of K-96, north of the Kansas Turnpike/K-96 intersection (Figure 4). The tract immediately west of K-96 was disturbed by a ditch, an east-west trending drainage, and the highway embankment (Figure 4.1). GSV was 40% or better, and was pedestrian surveyed. The only materials found were modern trash such as plastics, glass bottles, and some metal fragments.

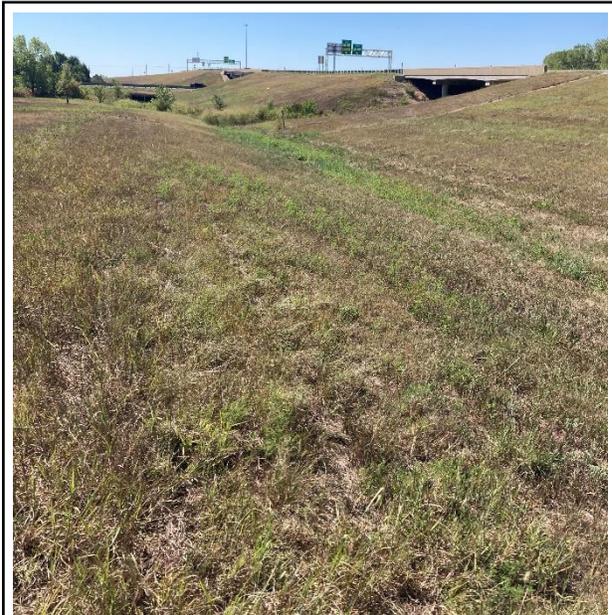
Figure 4.2. Image showing disturbances on the east side of K-96, facing south.

The tract to the west was partially disturbed at the north end and was pedestrian surveyed until the tree line. Within the trees, GSV was roughly 10% and was shovel tested on a single transect at 30m (98ft) intervals. Shovel tests revealed compacted, blocky, and friable clayey soils with mixed gravel indicating that this area had been disturbed. A single shovel test in the tract east of K-96 near the turnpike intersection showed similar, disturbed soil. Obvious disturbances included the highway embankment, a rock lined drainage, ditch, and a graded/leveled landform to the east (Figure 4.2).

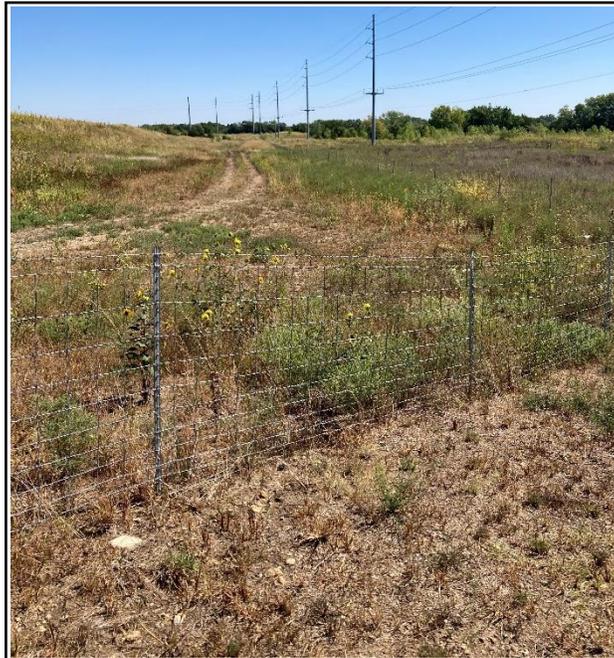
Figure 4.3. Image showing disturbances on the tract south of US-54/400 in Zone 1.

The tract south of US-54/400 that extends east off S 127th Street E (Figure 4) contained ground surface conditions conducive to pedestrian survey with 50% GSV on average. The area was largely disturbed by embankments on the north side, an access road, and high voltage overhead powerlines and poles on the south side (Figure 4.3). Asphalt and gravel were commonly seen on the surface. One sherd of glazed whiteware was found on the surface (Figure 4.4). Further to the east and just east of the quarter section line marked by a hedgerow, a handpump, cinder blocks, bricks, fencing materials, shingles, and a large oval-shaped sewer were found (Figures 4.4 and 4.5). Except for the hand pump and sewer which were fixed in the ground, the other materials were spread out over an area approximately 50m (164ft) in diameter. None of these materials contained maker's marks, or any other diagnostic information, and appeared to be fairly modern. The location of these items does not correspond to the location of any structures on the 1882 or 1905 county atlas plat maps.

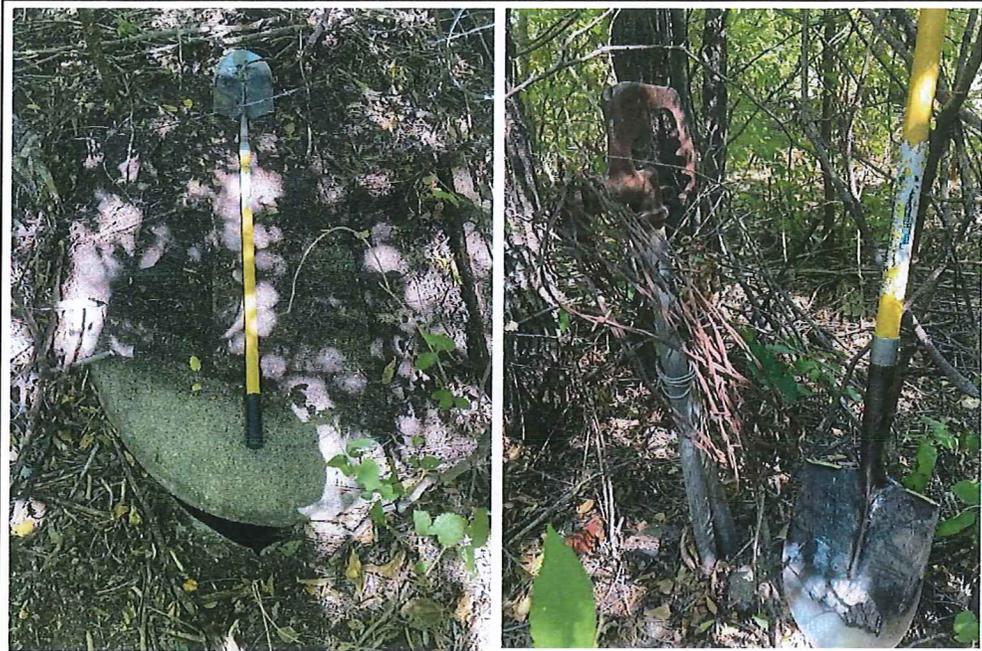
Figure 4.5. Two images showing a concrete, oval-shaped sewer (left), and a hand pump (right). Shovel is shown for scale.

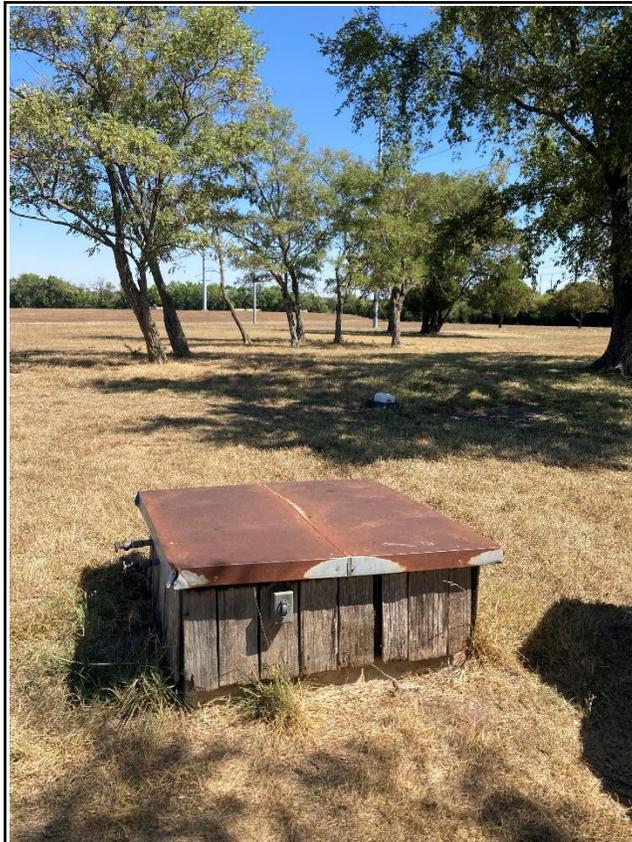
landowner who uses it for watering the trees and lawn, the well has been modernized with spigots, electric pumps and electrical outlets (Figure 5.2). Underneath the sheet metal cover and wood siding, it is a plain concrete box.

Figure 5.2. Image showing the well associated with site 14SG316, facing east.

The landowner mentioned that the property used to be a farmstead, and the house, now gone, was probably in the vicinity of the well and trees. Sedgewick County plat maps from 1882 and 1905 show structures in the general location of the site (Figure 5.3). However, no other materials were observed that could verify that they are one and the same. The site is well outside of the proposed construction limits and would not be adversely affected by the Project. In the author's opinion, the site lacks integrity and offers too little data to be eligible for NRHP nomination.

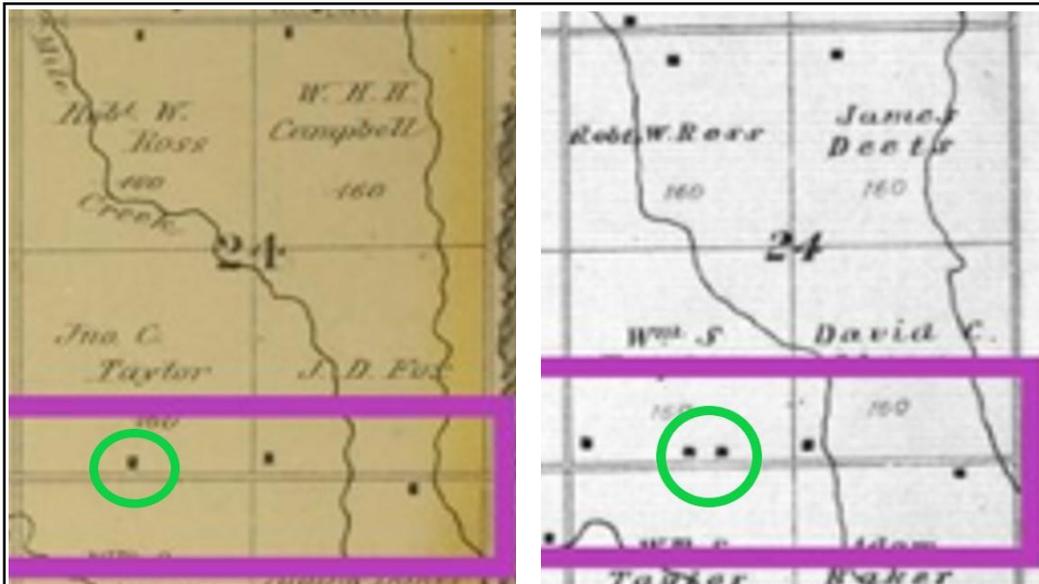
Figure 5.3. Two Sedgwick County plat maps from 1882 (left) and 1905 (right) showing structures in the vicinity of 14SG316 circled in green. The Project area is outlined in purple. T27S R2E

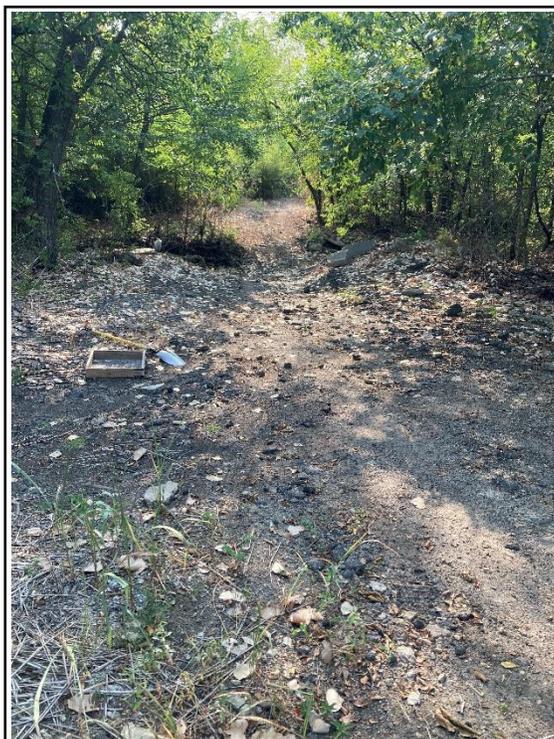
forested area around the drainage. The dirt/gravel path matched the survey tract exactly and contained 100% GSV (Figure 5.4). This tract was pedestrian surveyed. The path was not level or mechanically graded and small rises and falls in elevation were noted along the way. Two recently made campfires were found in this area, as local residents probably use this wooded area for recreation.

Figure 5.4. Image showing the dirt and gravel road.

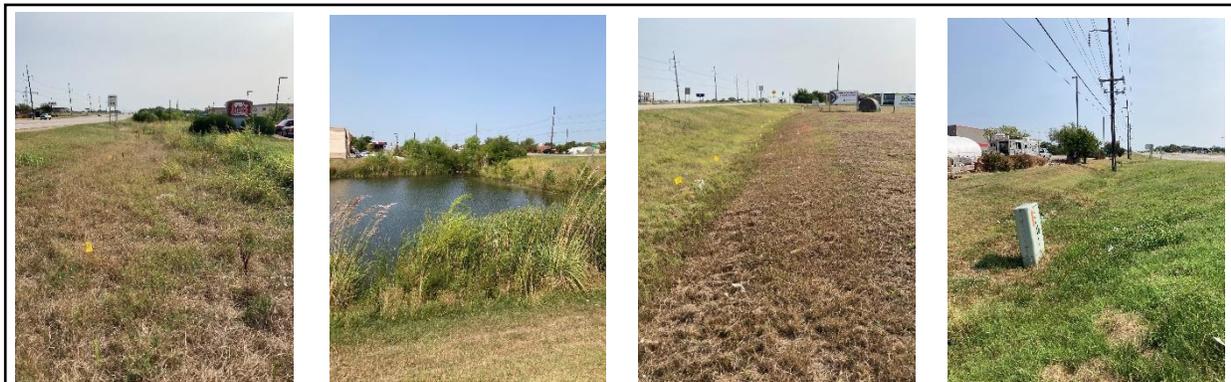
Zone 3 contains eight survey tracts between Andover Road and South Prairie Drive (Figure 6). Immediately east of Andover Road there are two tracts: one just north of US-54/400, and another just south of US-54/400. Both tracts were obviously disturbed and contained highway embankment, ditch, overhead powerlines and poles, buried utility lines, a pond, and commercial landscaping (Figure 6.1) These tracts were pedestrian surveyed. No cultural materials were observed.

Figure 6.1. Four images showing embankment, ditch, pond, power line poles (bottom right) and buried utilities (indicated with yellow and orange pin flags, top and bottom left).

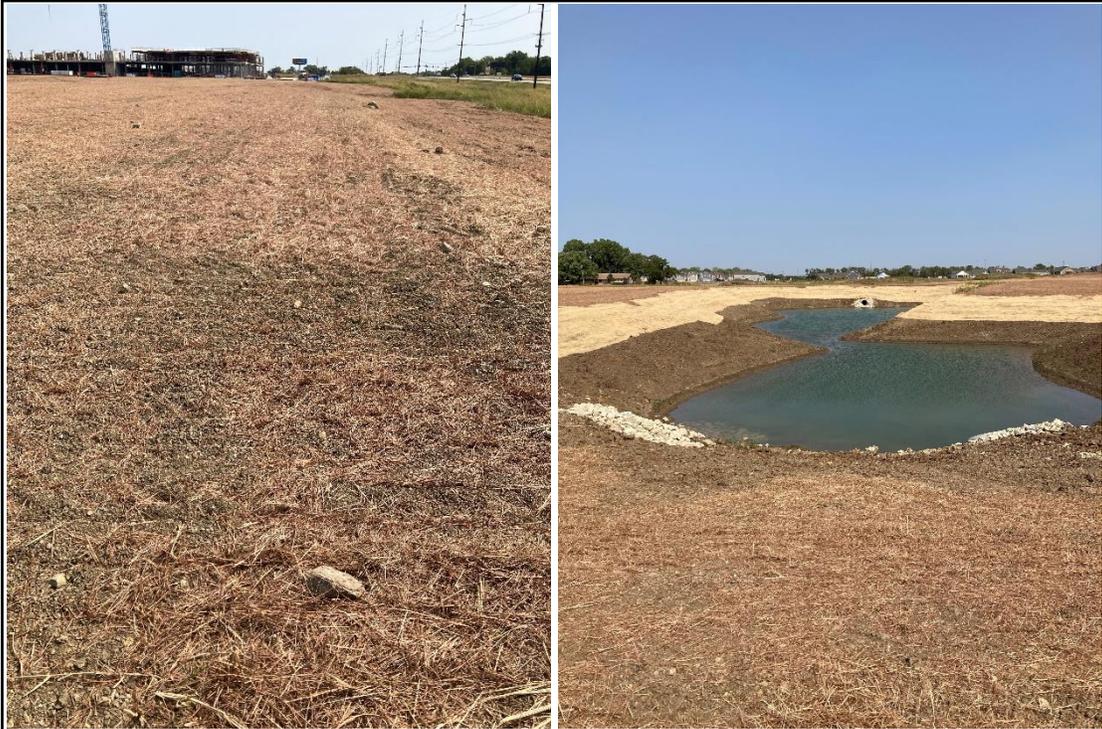
Another tract in this area is north of US-54/400 in the approximate center between Andover Road and Yorktown Road (Figure 6). This tract was in a field that appeared to consist of recently dumped soil, was mechanically raked, and leveled and covered with loose hay. (Figure 6.2). The soil was tan and mixed with gravel. GSV was 70% on average. Approximately 50m (164ft)

north of the survey tract was a recently made pond (Figure 6.2). No cultural materials were found in this tract.

Figure 6.2. Two images showing a field (left) and a recently made pond (right).

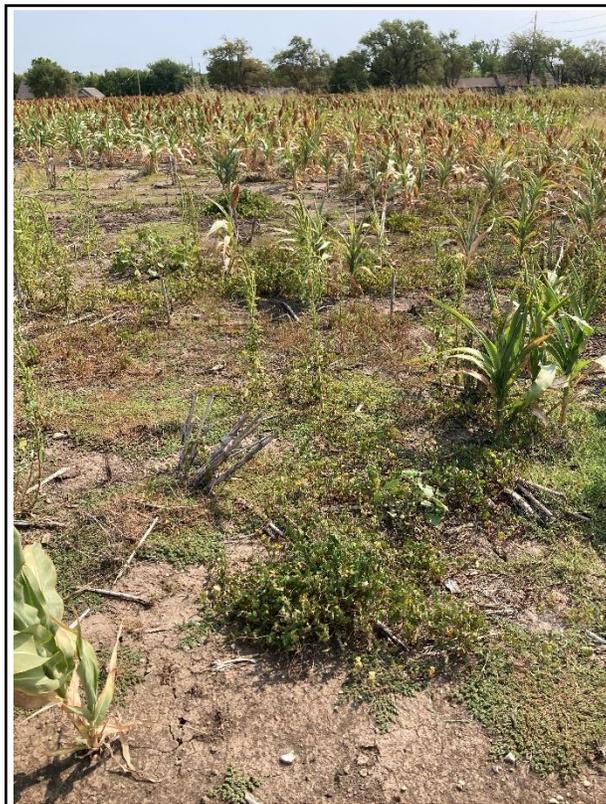
The small tract north of US-54/400 immediately east of Yorktown Road (Figure 6) was in a milo field with 80% GSV (Figure 6.3). Five small shards of thin, flat, aqua glass were found spread out across the field with no apparent patten or clustering. No significant cultural materials were found in this tract.

Figure 6.3. Image showing a milo field.

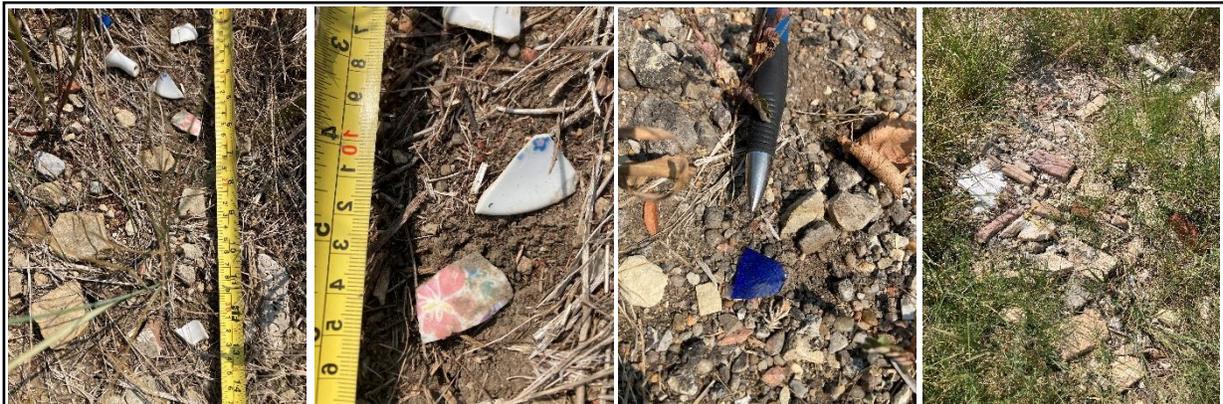
North of US-54/400 and east of S Prairie Creek Road are two tracts: one heading north-south, and the other heading east-west (Figure 6). The former tract consisted of a thick hedge row along the road and short grass on the east. GSV was ~50% and was pedestrian surveyed. The latter tract was also covered in short grass with ~60% GSV. This tract was pedestrian surveyed. A diffuse scatter of glazed whiteware with colored motifs, cobalt glass, limestone blocks, bricks and miscellaneous building materials were found (Figures 6.5 and 6.6). Most of the building materials appeared to have been pushed into piles in the hedgerow.

Figure 6.6. Images showing glazed whiteware with colored motifs (left and center-left), cobalt glass (center-right) and miscellaneous building materials (right).

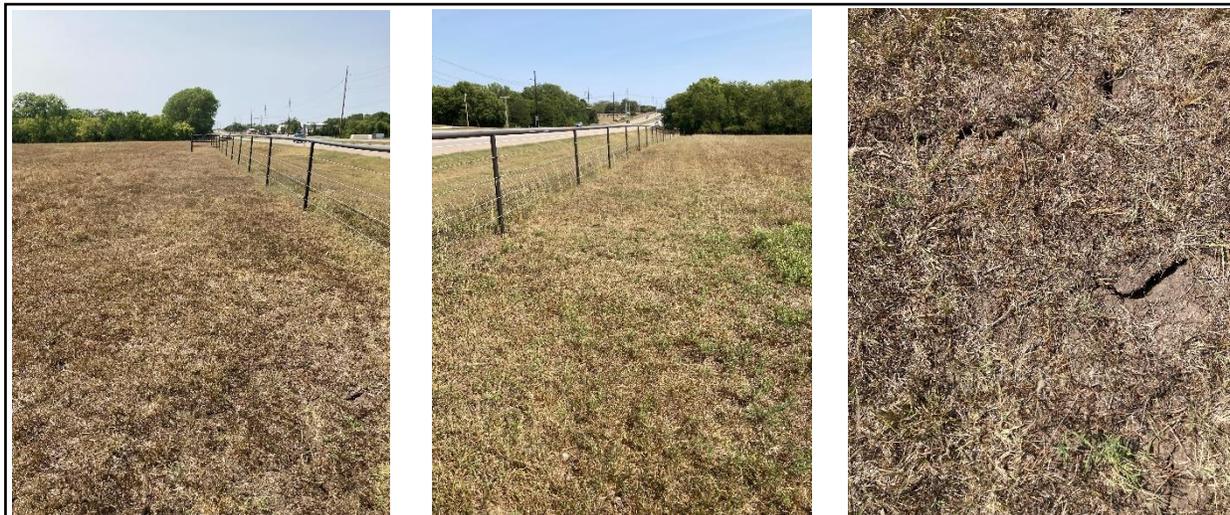
The long tract south of US-54/400 between S Prairie Creek Road and S Prairie Creek Drive (Figure 6) is primarily pasture for horses. The landform was high in the middle and sloped evenly towards drainages on the east and west ends (Figure 6.8). The drainage on the east end is Republican Creek. The pasture was pedestrian surveyed as the survey tract was in recently mowed short grass with 40% GSV. No cultural materials were found in the pasture.

Figure 6.8. Image showing the western portion of the pasture (left). Image showing the east side of the pasture (center). Image showing GSV (right).

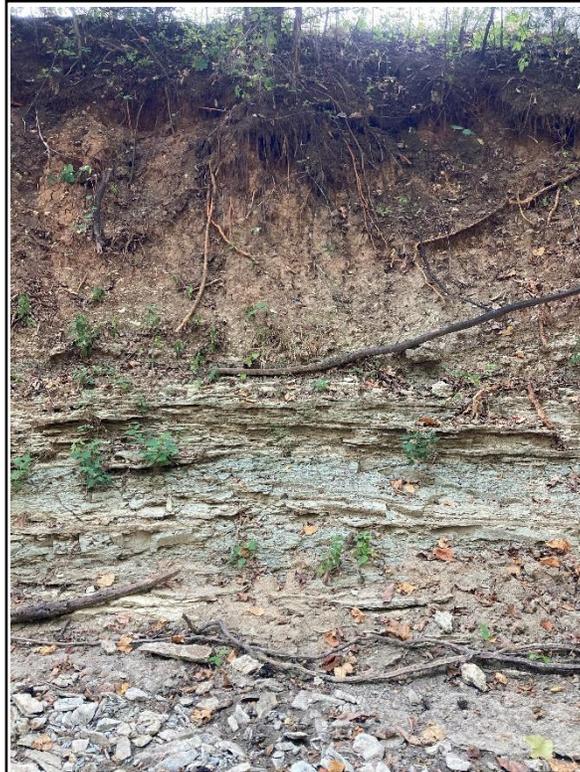
The western drainage was dry and had roughly 1m (3.3ft) high cutbanks. The cutbanks and bottom was inspected for cultural materials that may have become exposed due to erosion. None were found. The eastern drainage, Republican Creek, had shallow standing water in some parts and the bottom was sometimes exposed. To the south, there was a 2-3m high cutbank providing a geological profile (Figure 6.9). Other than modern garbage, no cultural materials were found.

Figure 6.9. Image showing a cut bank of Republican Creek.

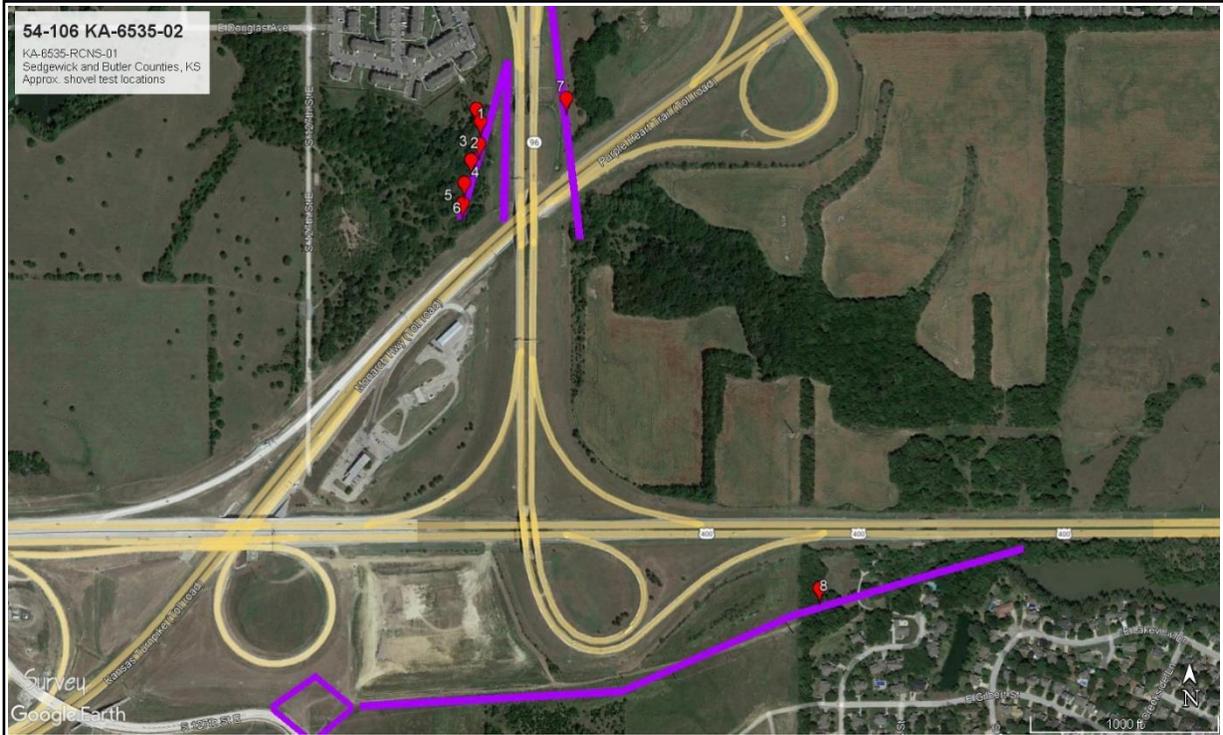
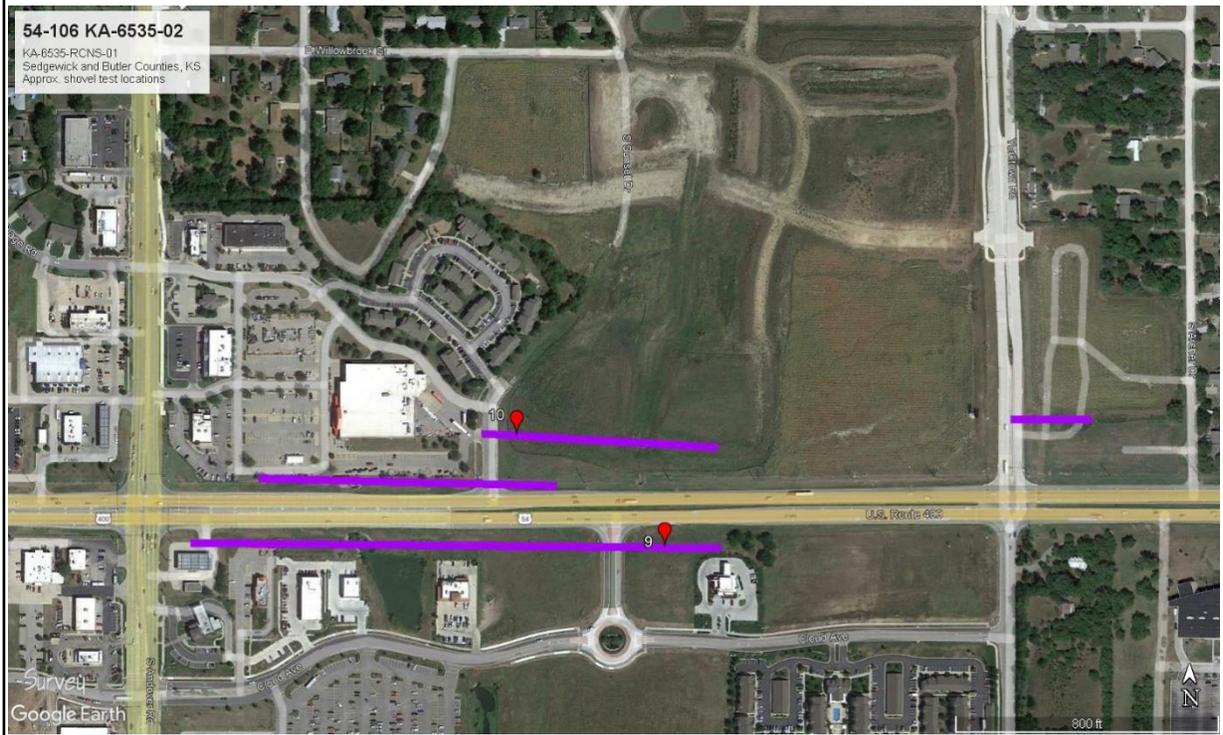
Figure 7. Two aerial images showing the approximate locations of shovel tests.

1	Zone: 14S	N: 4172437	E: 659908
0-30cmbs: gray-brown silty clay loam with white pebbles			
2	Zone: 14S	N: 4172417	E: 659915
0-25cmbs: gray-brown silty clay loam with white pebbles @25cmbs: impassable roots			
3	Zone: 14S	N: 4172381	E: 659914
0-35cmbs: gray-brown silty clay loam with white pebbles			
4	Zone: 14S	N: 4172355	E: 659901
0-20cmbs: gray-brown silty clay loam with angular gravel			
5	Zone: 14S	N: 4172318	E: 659891
0-30cmbs: dark gray clayey loam, blocky and friable			
6	Zone: 14S	N: 4172285	E: 659889
0-30cmbs: dark gray clayey loam, blocky and friable			
7	Zone: 14S	N: 4172457	E: 660053
0-30cmbs: dark gray clayey loam, blocky and friable			
8	Zone: 14S	N: 4171678	E: 660477
0-30cmbs: dark gray clayey loam, blocky and friable			
9	Zone: 14S	N: 4171865	E: 664914
0-30cmbs: multi-colored clayey loam, blocky and friable. Mixed angular gravel.			
10	Zone: 14S	N: 4171965	E: 664775
0-10cmbs: light tan silty clay loam, gravel @10cmbs: gravel
