APPENDIX D: Water Resources

TOPIC: US 54/East Kellogg Expansion – Water Features Delineation Report

AUTHOR: David Partridge

DATE: 06/28/2022

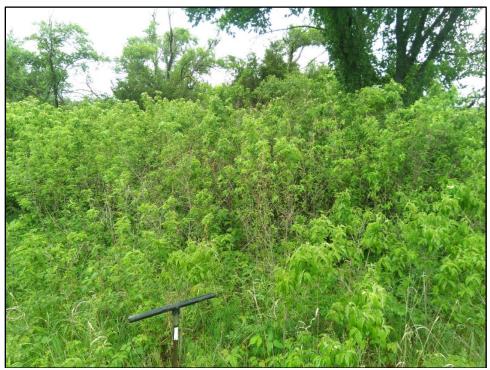
Photograph C-1: View of upland Sample Plot (SP)-D-1, facing north.

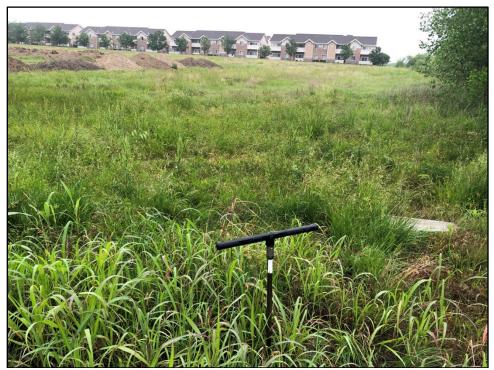
Photograph C-7: View of upland SP-D-7, facing northeast.

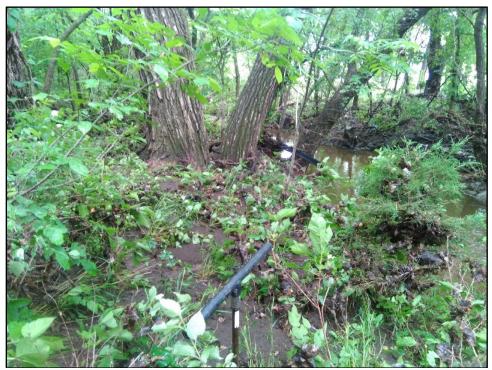
Photograph C-9: View of upland SP-D-9, facing west.

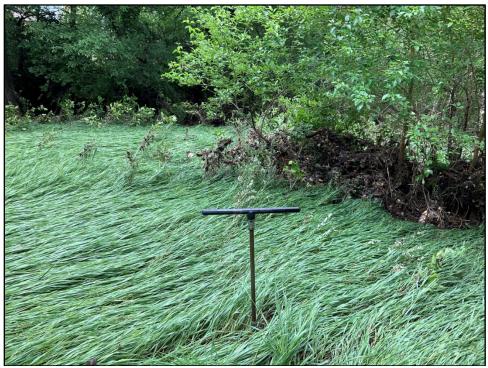
Photograph C-10: View of upland SP-D-10, facing northwest.

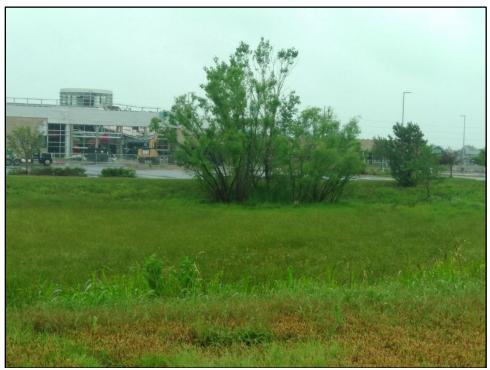
Photograph C-13: View of SP-D-13 in PSS W-D-11, facing north.

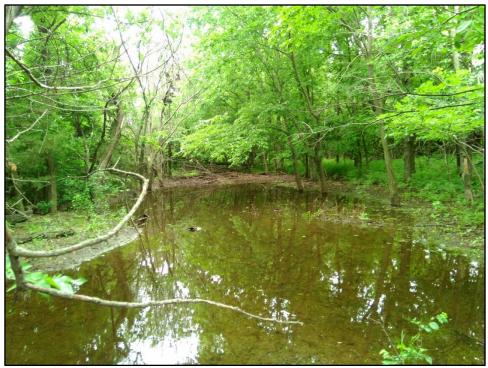
Photograph C-14: View of PUB W-D-1, facing south.

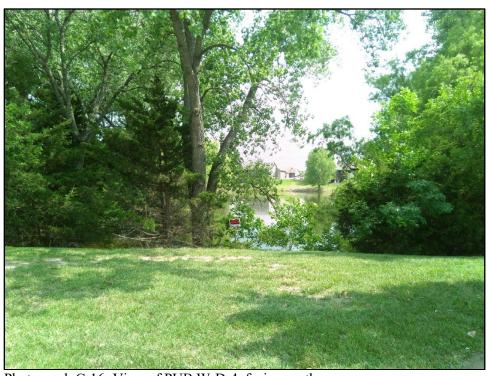
Photograph C-16: View of PUB W-D-4, facing north.

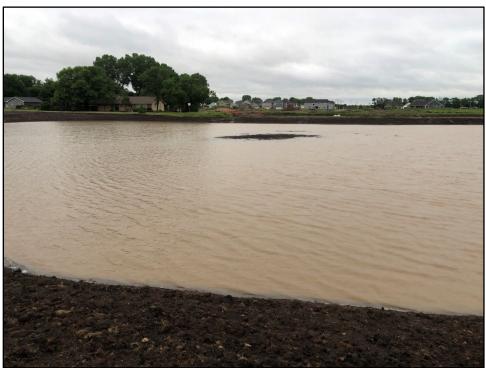
Photograph C-19: View of PUB W-D-7, facing northeast.

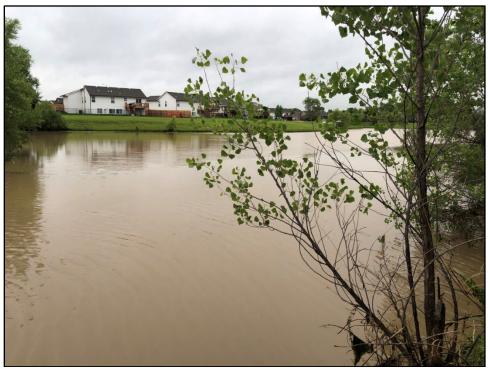
Photograph C-20: View of PUB W-D-8, facing east.

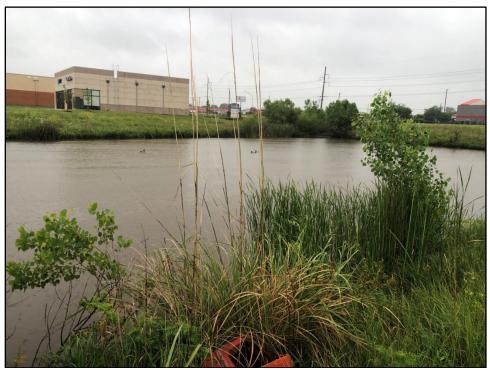
Photograph C-21: View of PUB W-D-10, facing east.

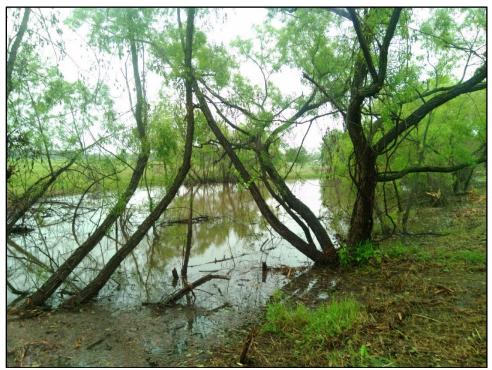
Photograph C-23: View of PUB W-D-13, facing southeast.

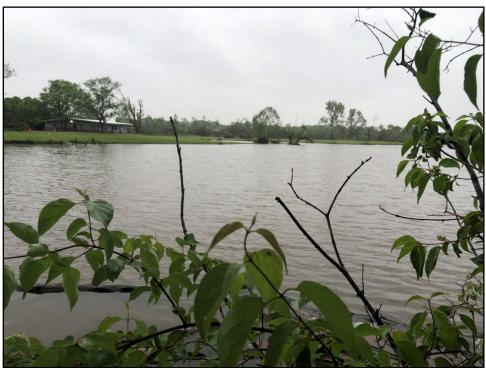
Photograph C-25: View of PUB W-D-15, facing west.

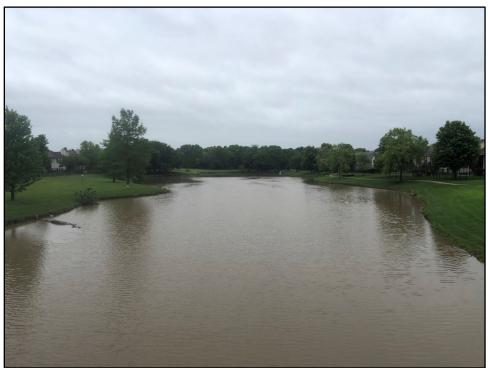
Photograph C-27: View of PUB W-D-17, facing north.

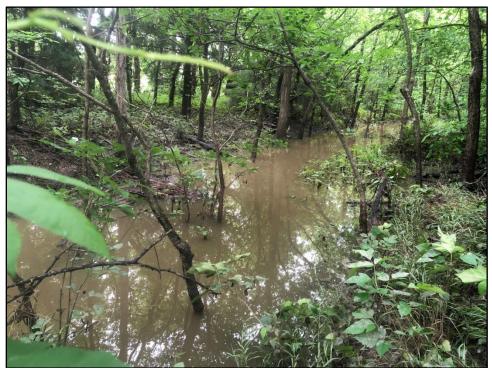
Photograph C-29: View of PAB W-D-19, facing south.

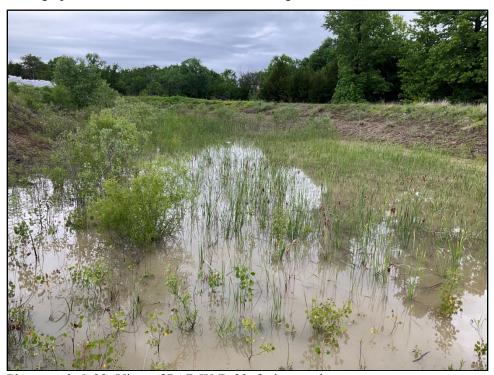
Photograph C-32: View of PAB W-D-22, facing north.

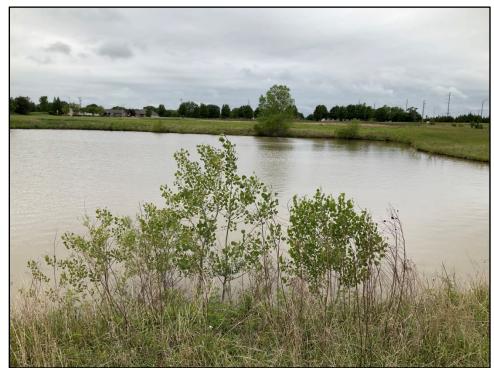
Photograph C-33: View of PUB W-D-23, facing west.

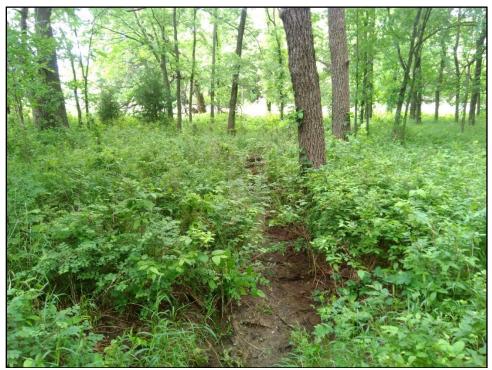
Photograph C-39: View of ephemeral S-D-3, facing south.

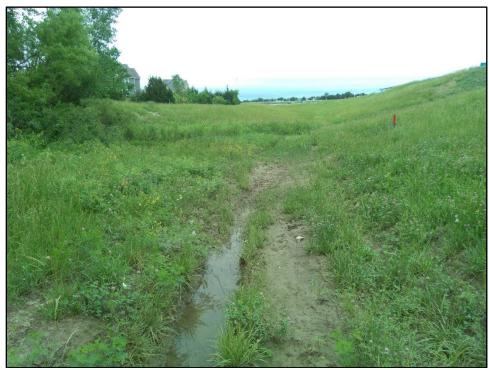
Photograph C-41: View of ephemeral S-D-5, facing north.

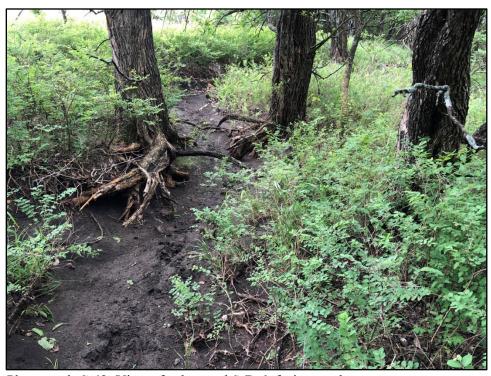
Photograph C-42: View of ephemeral S-D-6, facing north.

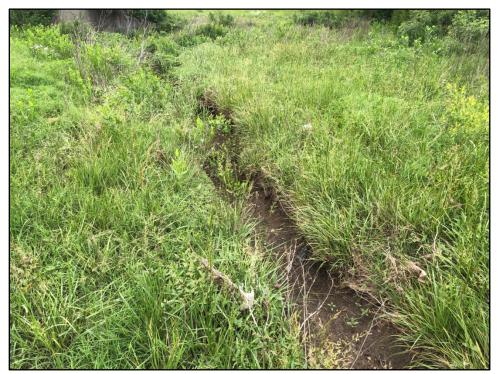
Photograph C-43: View of ephemeral S-D-7, facing northeast.

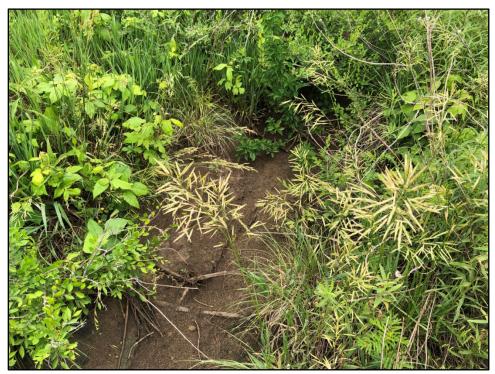
Photograph C-45: View of ephemeral S-D-9, facing south.

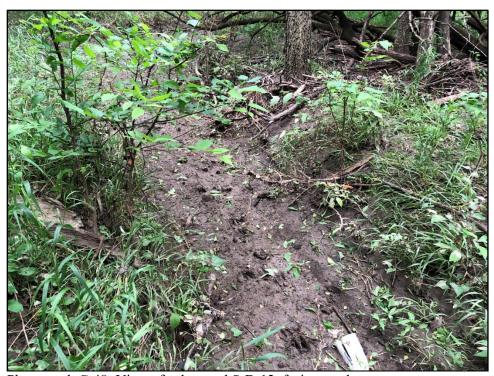
Photograph C-48: View of ephemeral S-D-12, facing northeast.

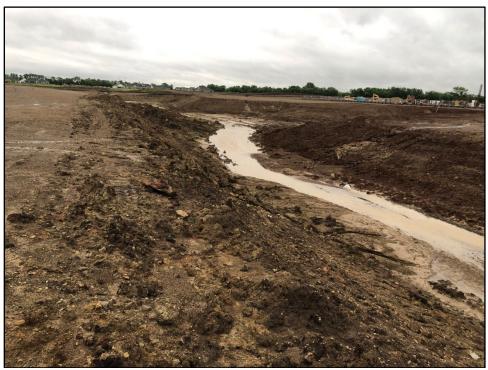
Photograph C-49: View of intermittent S-D-13, facing north.

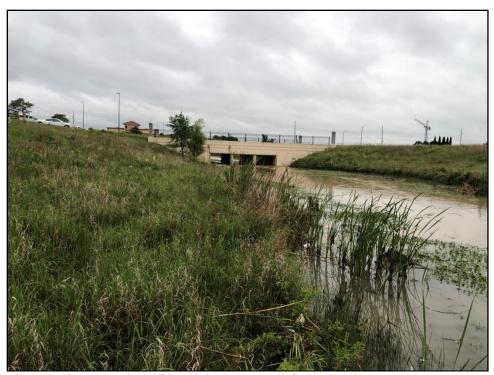
Photograph C-50: View of intermittent S-D-14, facing north.

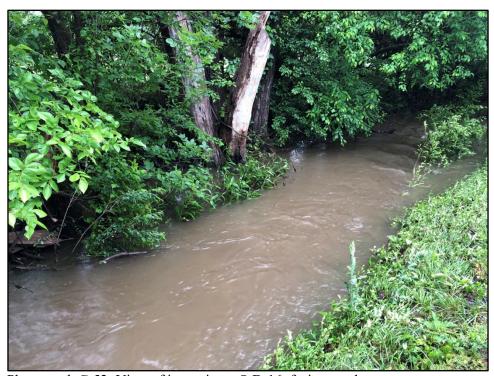
Photograph C-52: View of intermittent S-D-16, facing south.

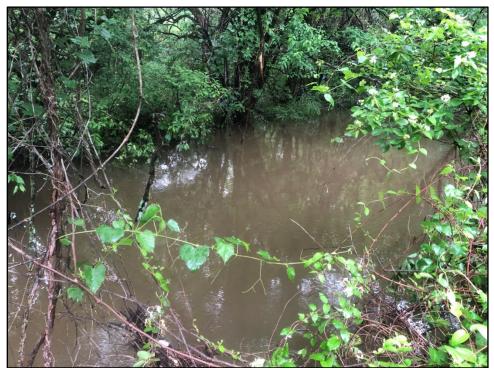
Photograph C-53: View of intermittent S-D-17, facing north.

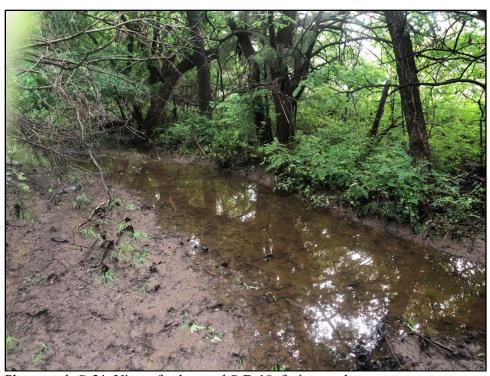
Photograph C-54: View of ephemeral S-D-18, facing north.

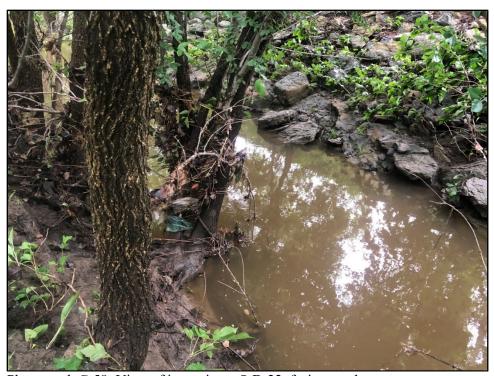
Photograph C-58: View of intermittent S-D-22, facing southwest.

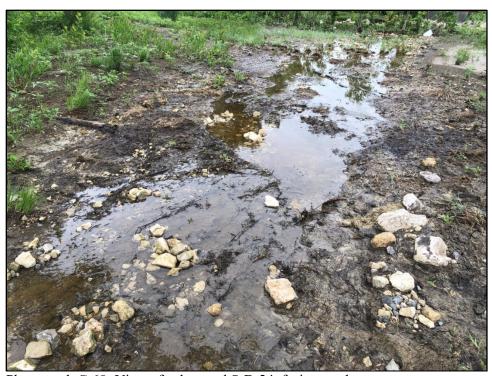
Photograph C-60: View of ephemeral S-D-24, facing north.

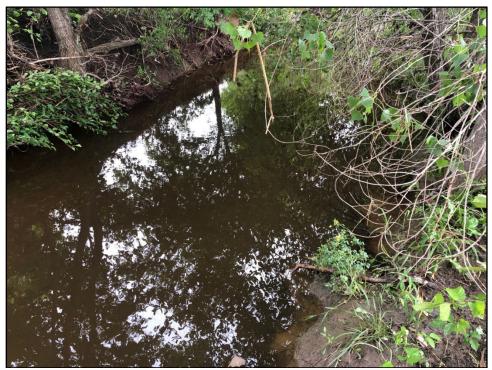
Photograph C-61: View of intermittent S-D-25, facing south.

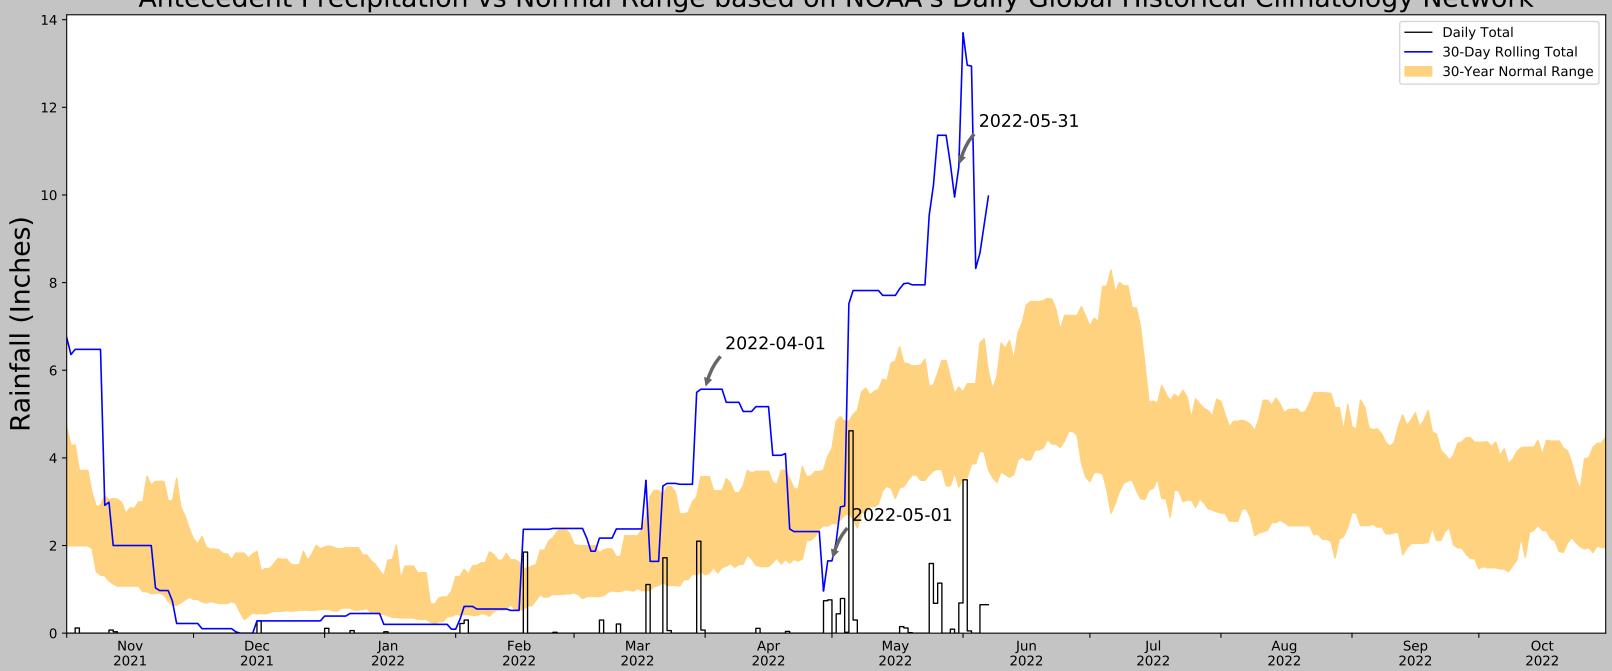
Coordinates	37.680398, -97.176049
Observation Date	2022-05-31
Elevation (ft)	1314.47
Drought Index (PDSI)	Mild drought
WebWIMP H ₂ O Balance	Wet Season

CORPS OF ENGINEERS	Figure and tables made by the Antecedent Precipitation Tool Version 1.0
REGULATORY PRESENT	Written by Jason Deters U.S. Army Corps of Engineers

The USACE Antecedent Precipitation Tool indicates that the region near Survey Area experienced wetter than normal precipitation conditions the three months before the field efforts (Appendix D).
